979 Arrowhead Ranch Boulevard Dripping Springs, Texas 787620

# **PROPERTY INSPECTION REPORT FORM**

Robert Spellings	09/22/2023 2:30 pm
Name of Client	Date of Inspection
979 Arrowhead Ranch Boulevard, Dripping Springs, Texas 787620	
Address of Inspected Property	
Ion Santesteban	TREC #23815
Name of Inspector	TREC License #
Name of Sponsor (if applicable)	TREC License #

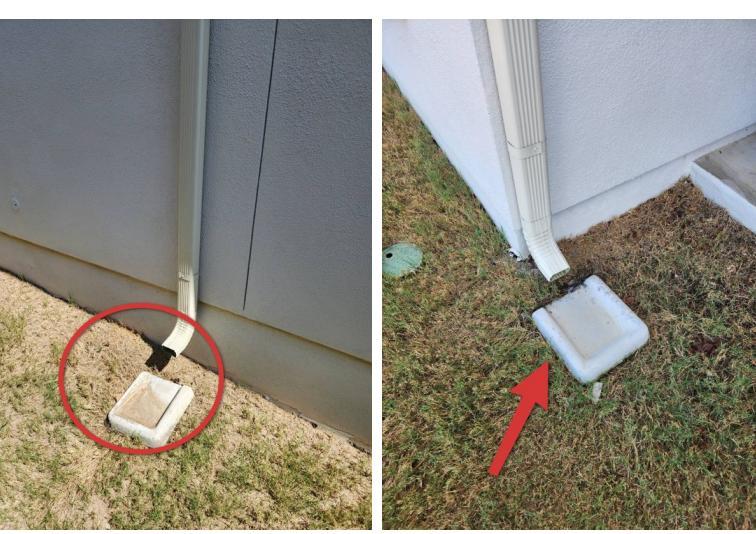
- The left and back water diverter pads are installed backward.

Left side - water diverter pad.

Backyard - water diverter pad.

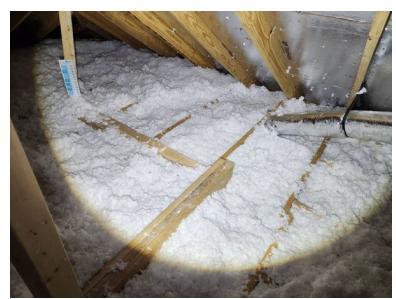
- The insulation depth throughout the attic crawlspace is inconsistent. Recommend leveling out the insulation to help maximize its efficiency.

Back - inconsistent insulation.

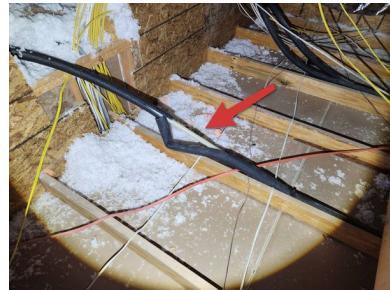
- There are uninsulated water supply lines. They should be insulated for freeze protection.

Uninsulated water supply line.

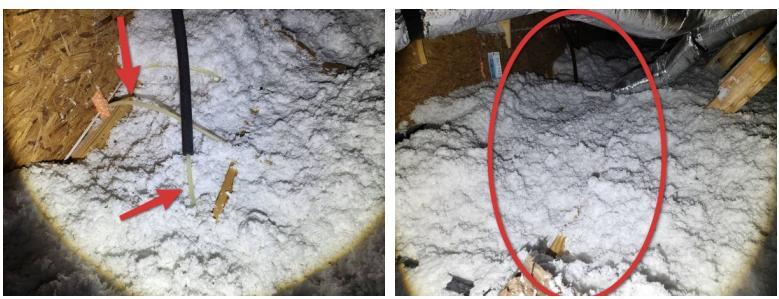
Uninsulated water supply lines.

Inconsistent insulation.

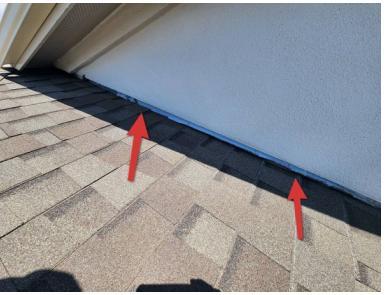
Left side, second floor wall - building wrap.

- In the second-story wall, recommend removing the excess building wrap at the bottom of the second-story wall.

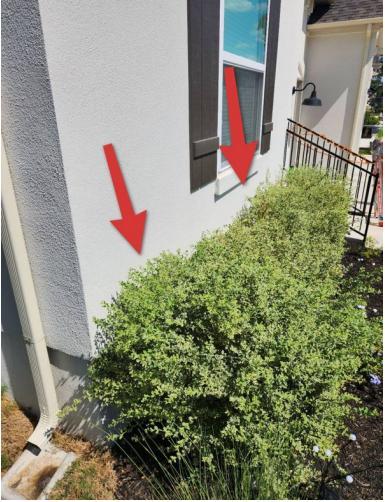
- There is vegetation in contact with the structure. Recommend trimming and maintaining tree limbs and foliage away (at least 5 feet) from contact with the house.

Front - vegetation.

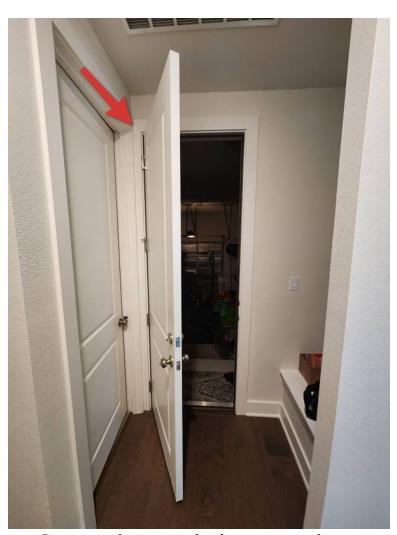
- The door between the garage and the interior of the house should be equipped with an auto-closer device to prevent automobile fumes from entering the house.

Garage door - missing auto-closer device.

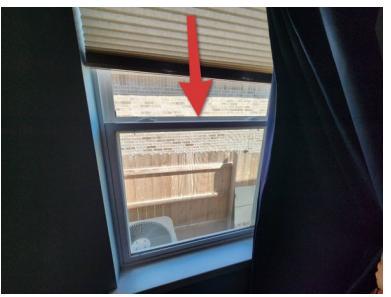
- Unable to operate (open or close/latch) the front right bedroom window. Recommend necessary repairs to be done.

Front right bedroom window - inoperable.

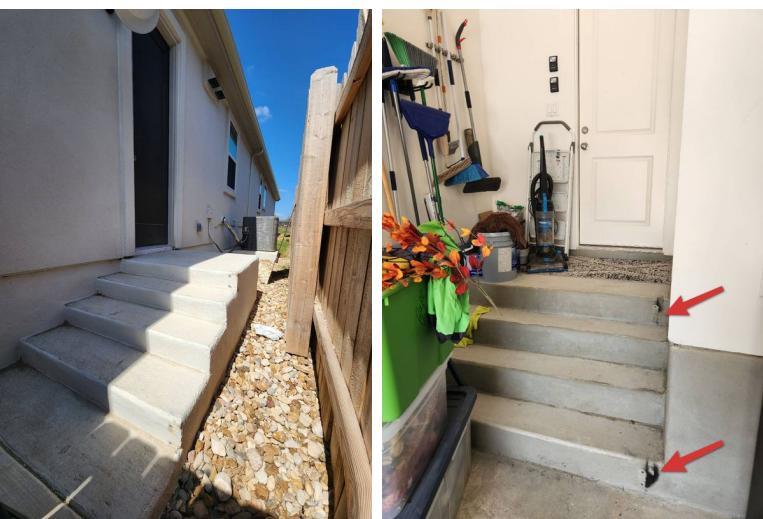
- On the right side yard, the stairs are missing a handrail/guardrail.
- Inside the garage, the stairs are missing a handrail.

Right side - missing handrail/guardrail.

Garage stairs - missing handrail.

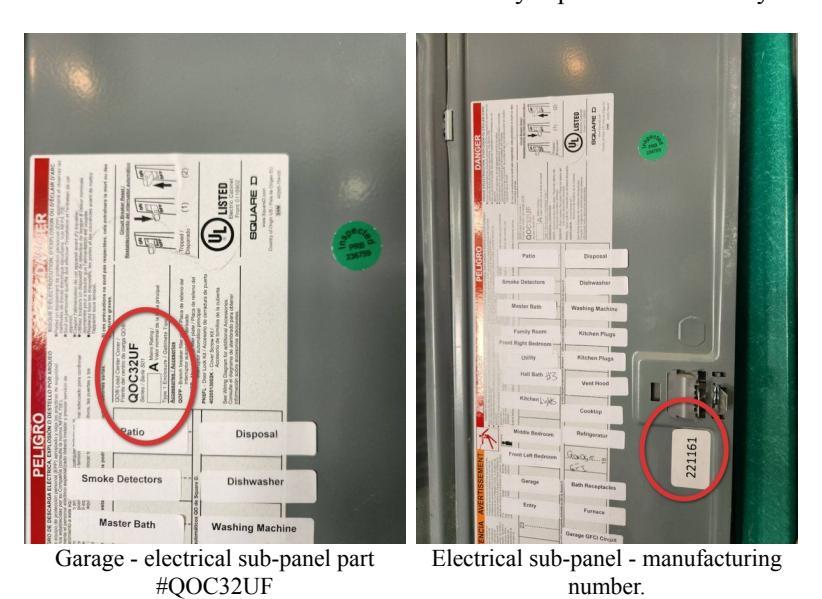
- In the garage, the existing electrical sub-panel has been recalled by the manufacturer. Recommend further investigation into Schneider Electric/Square D electrical panels at the Consumer Product Safety Commission website. Recommend necessary repairs to be done by a licensed electrician.

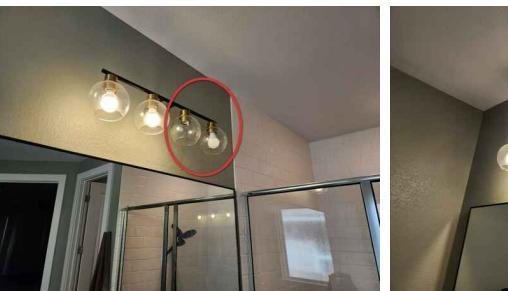
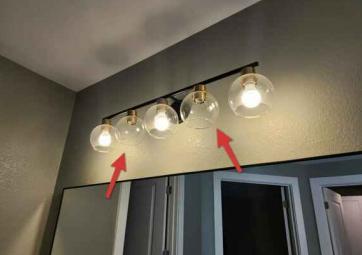
- The light fixtures are missing light bulbs and/or have inoperable light bulbs.

Master bathroom light fixture.

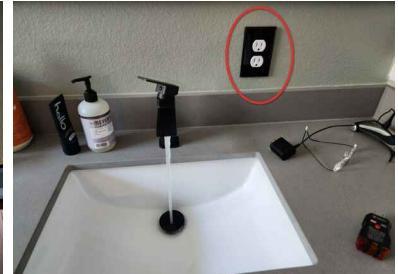
- The right sink outlet is loose.

Master bathroom - loose outlet.

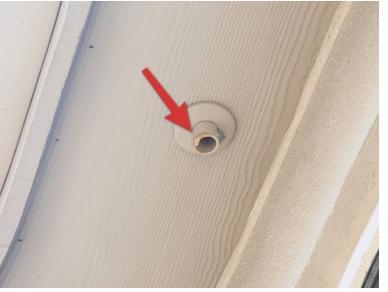
- On the right side soffit, the A/C emergency pan drain is leaking.

Right side, soffit - A/C emergency pan drain

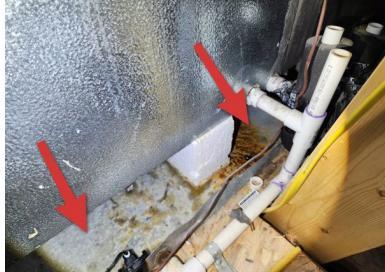
- In the attic, there is water present at the A/C emergency pan. Recommend further evaluation of the system by a licensed HVAC technician.

Attic, A/C emergency pan - water.
